## Fixing oil leaks from the gearbox rear seal area

Gearbox oil leaks that appear to come from the rear seal are sometimes due to a design flaw that can allow oil to seep along the output splined shaft. Here is a way of sealing the leak without removing the gearbox or the rear drive.

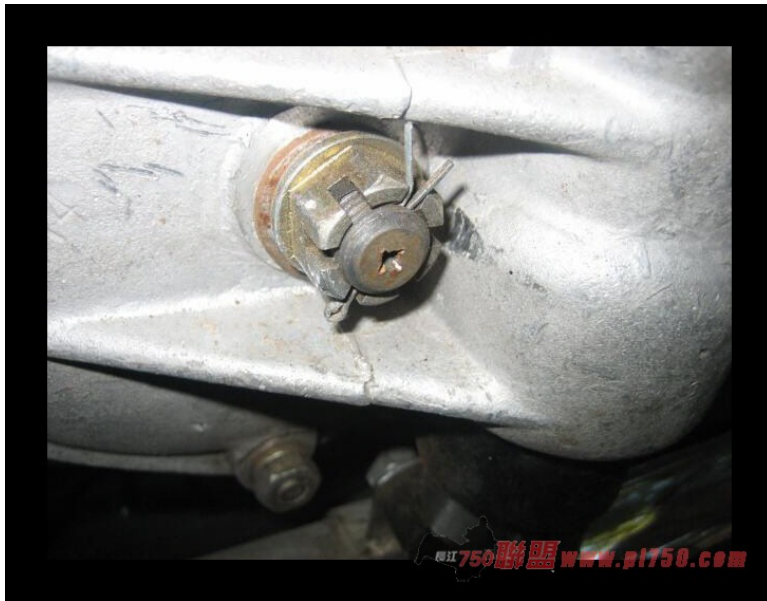
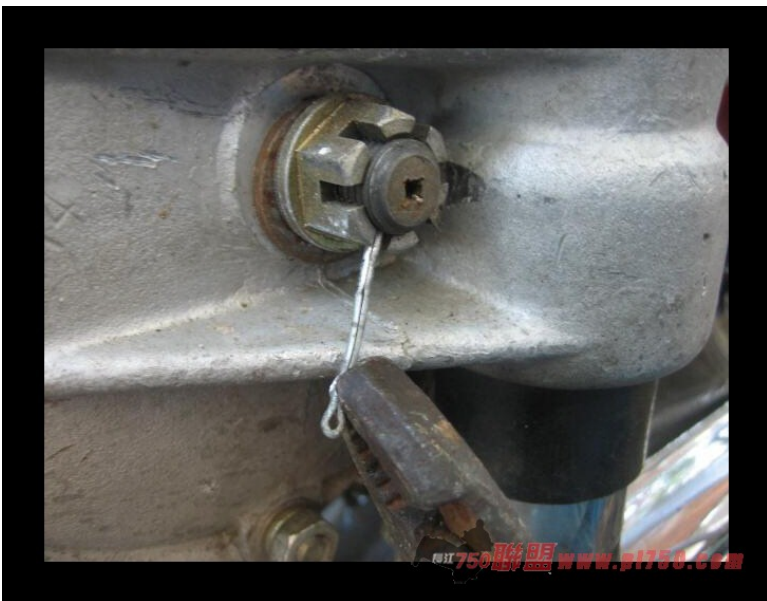
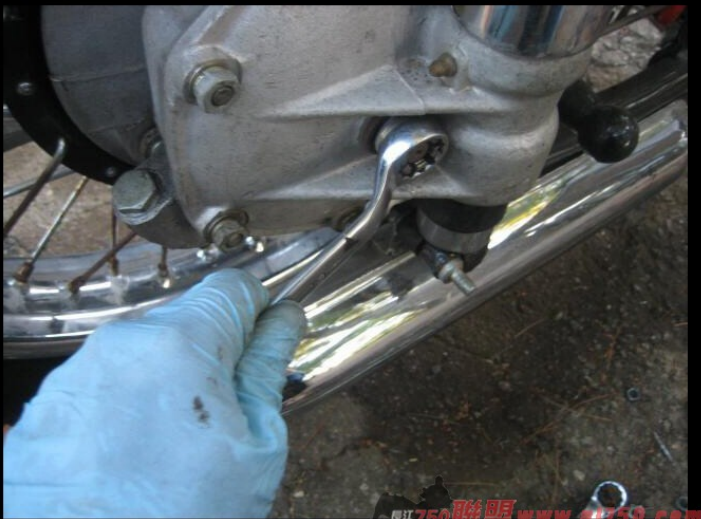
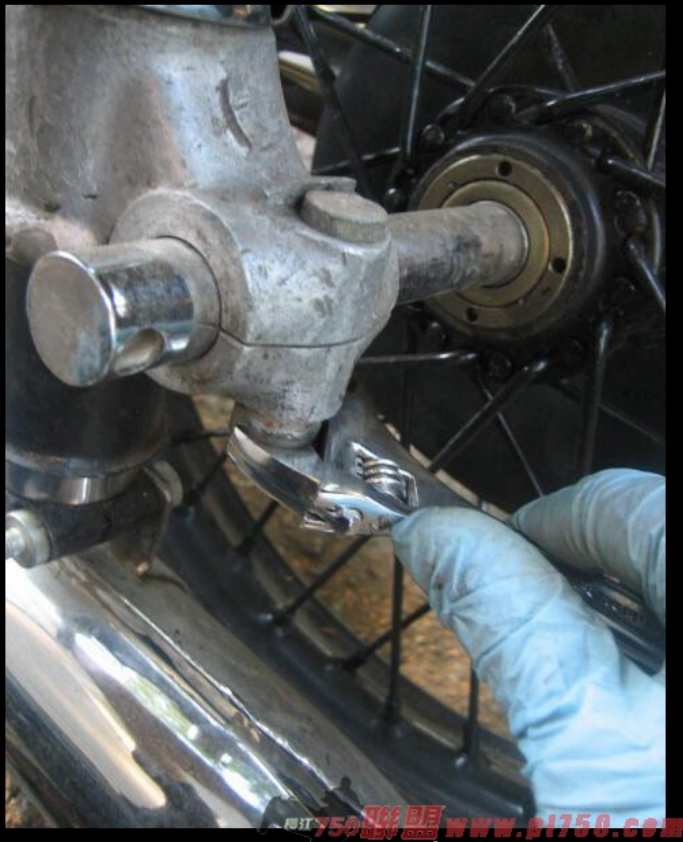
Start by removing the rear axle nut.

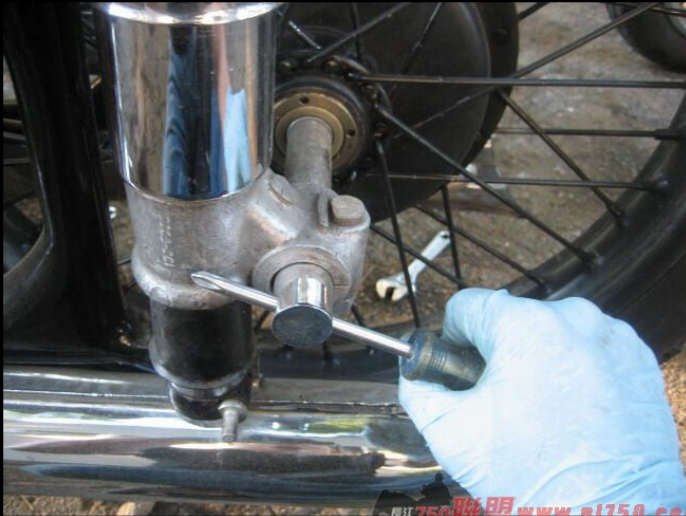
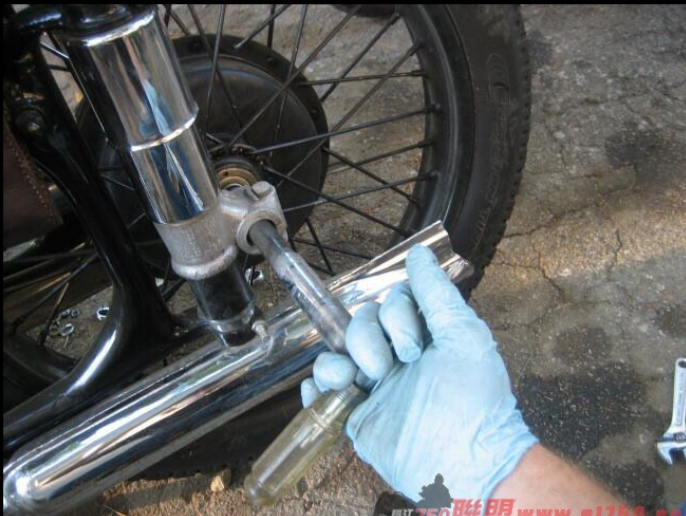
Next, loosen the pinch bolt on the left side, but don't remove the nut.

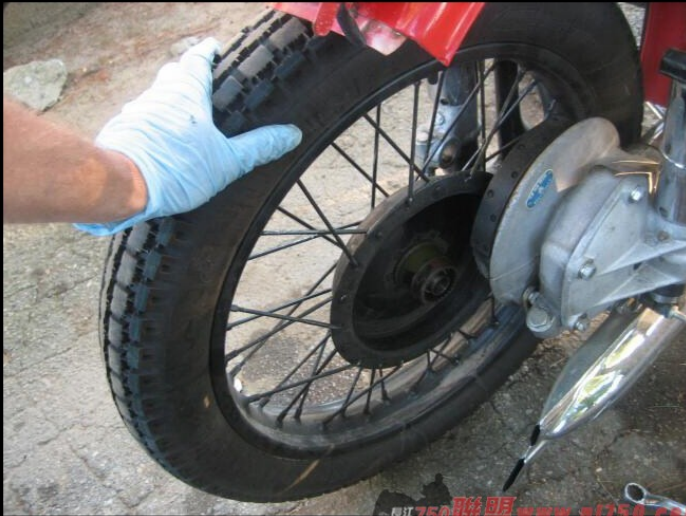
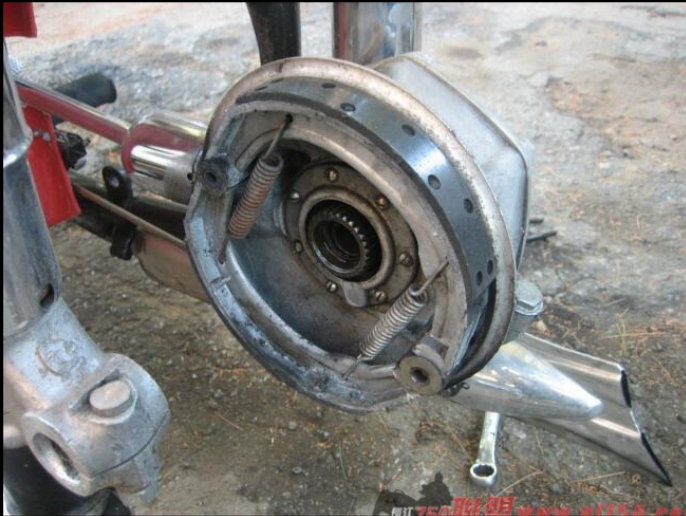
Pull out the rear axle.

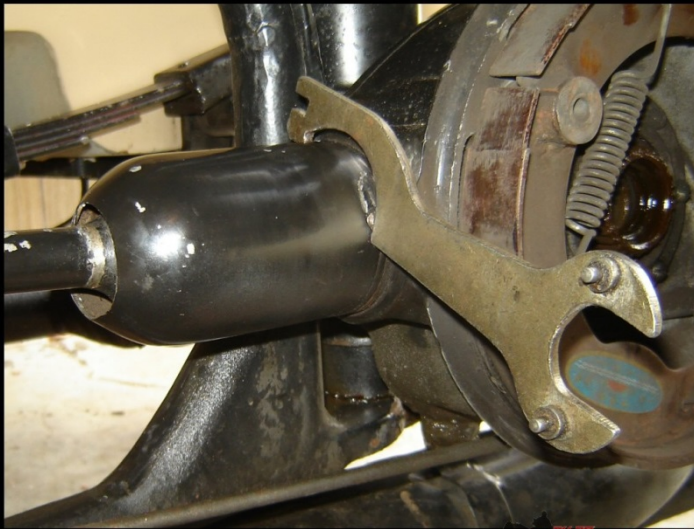
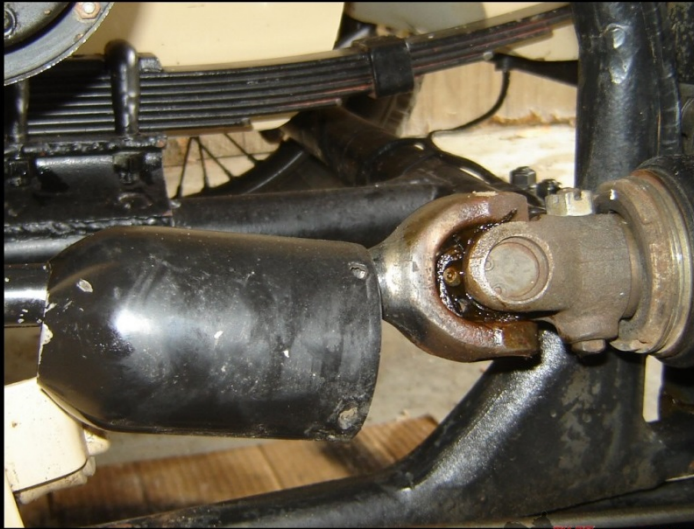
Next, remove the universal joint cover using a hook spanner. Note that it has a left-hand thread; screw it clockwise to remove it.

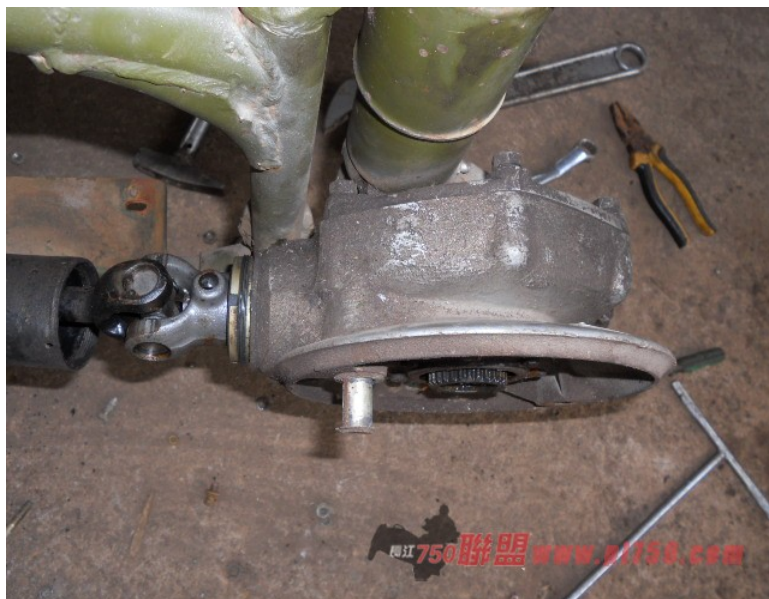
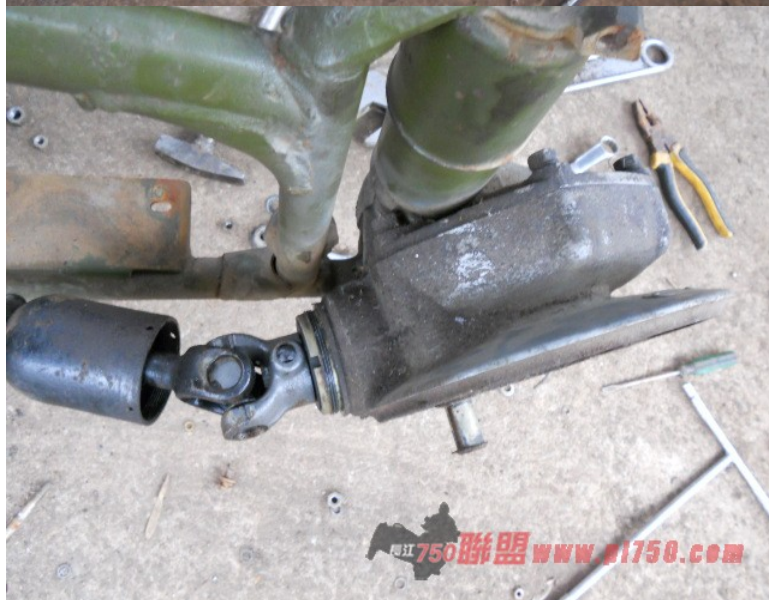
Now turn the driveshaft so that the universal joint is as shown. This allows the rear drive to be rotated, disconnecting the driveshaft from the gearbox.

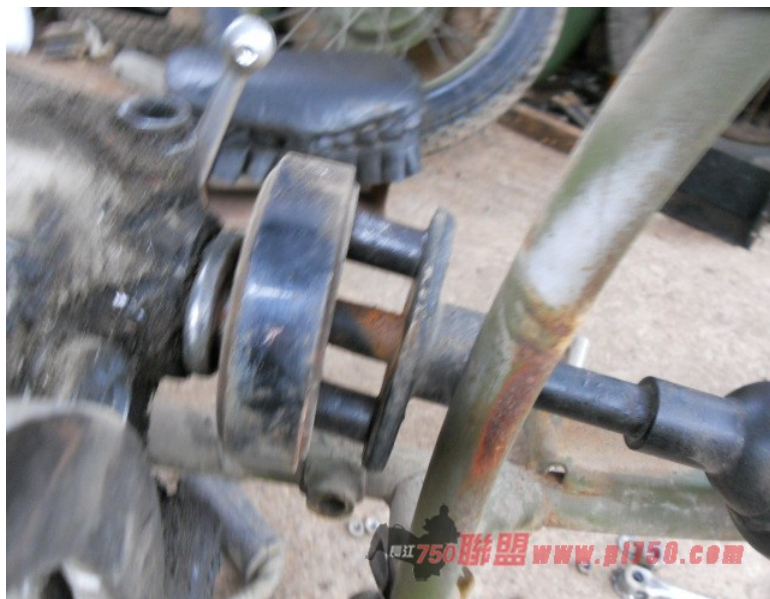
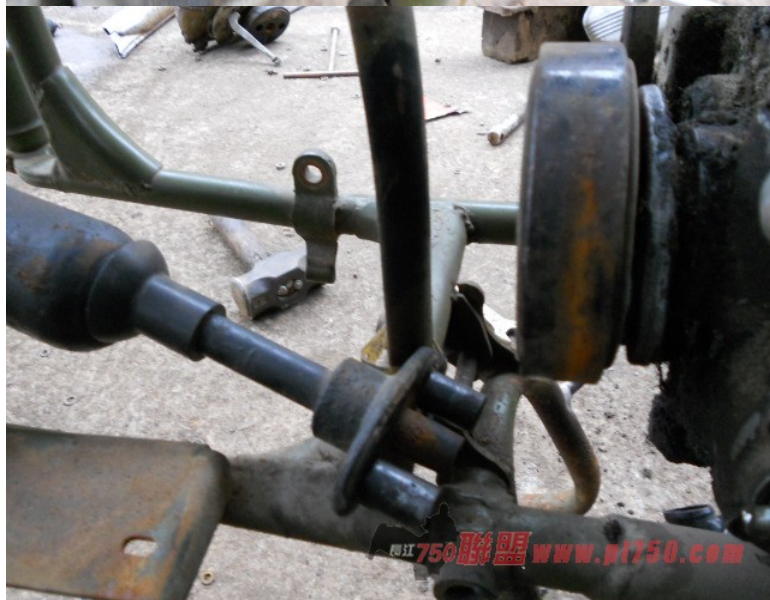
Swing the driveshaft out of the way and remove the rubber damper disk from the gearbox.

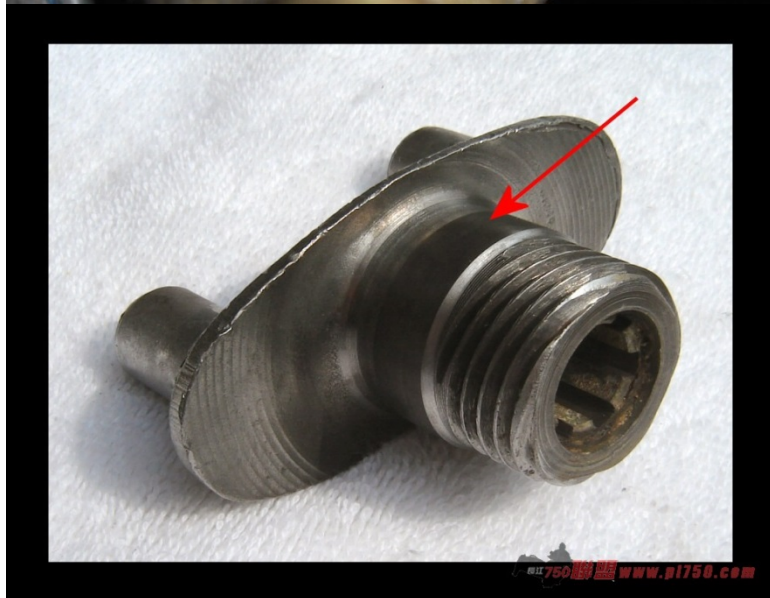
Undo the retaining nut, and remove the rubber disk connector part. Inspect the area in contact with the oil seal (red arrow), and make sure its surface is smooth.

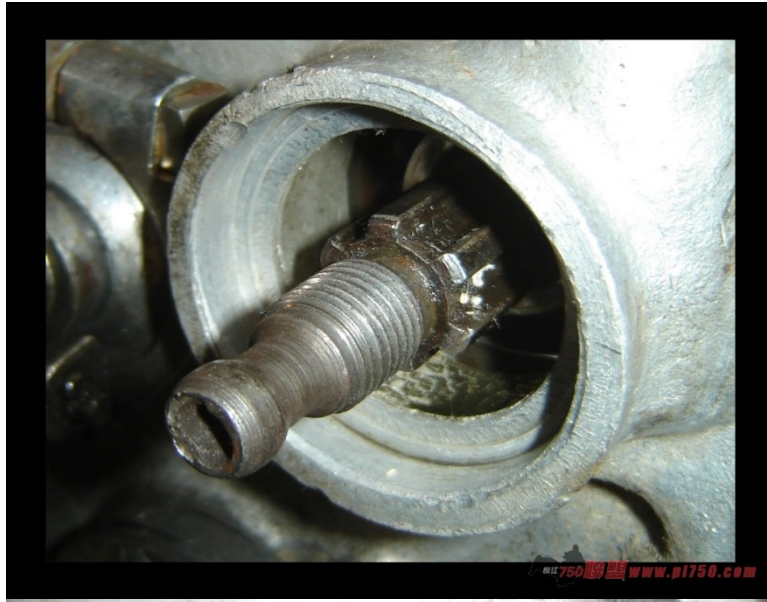
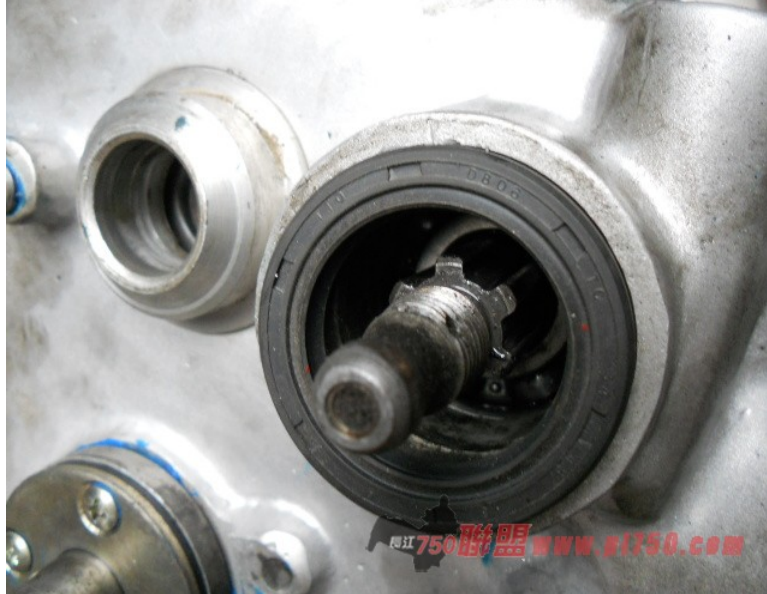
Remove the old oil seal, clean up the surface and install a new oil seal, applying gasket sealer to the outer edge. The seal is CJ750 part number 723126, a metric seal measuring 36.5x48x8mm.

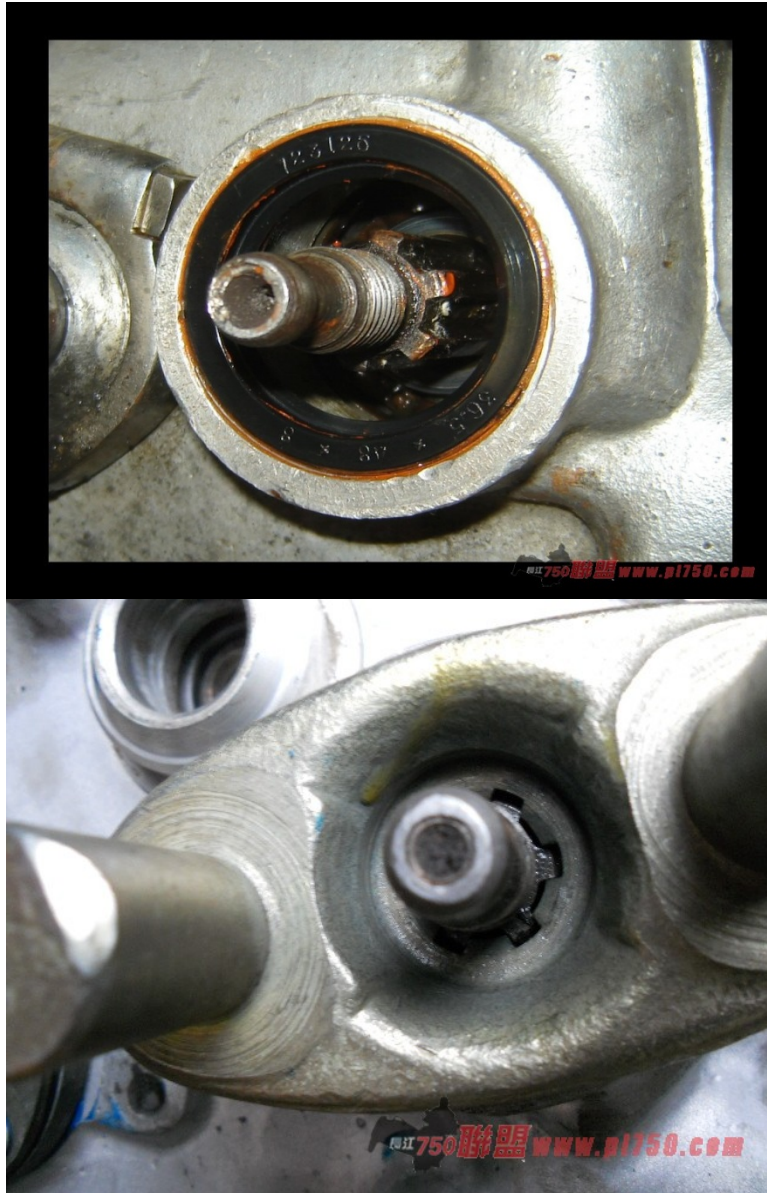
You can see by these two pictures that the seal will stop oil from leaking from the outside of the rotating part, but nothing stops oil from seeping along the splined shaft.

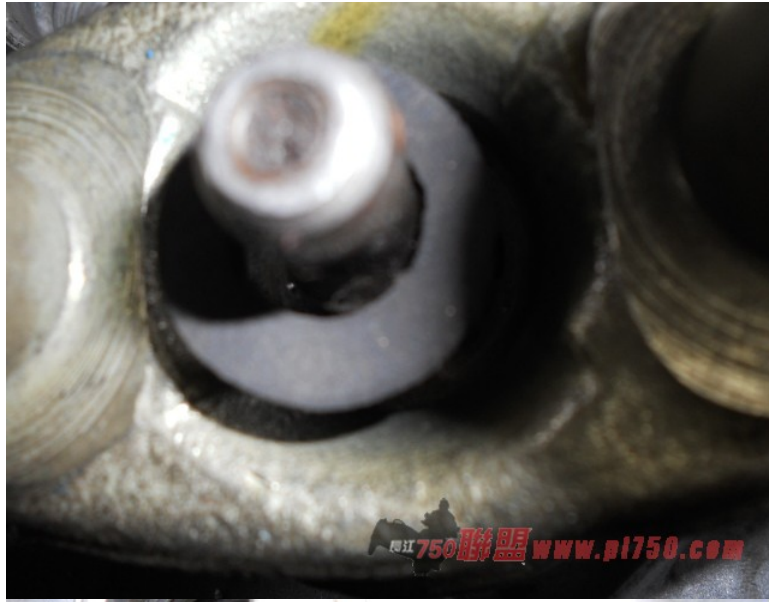
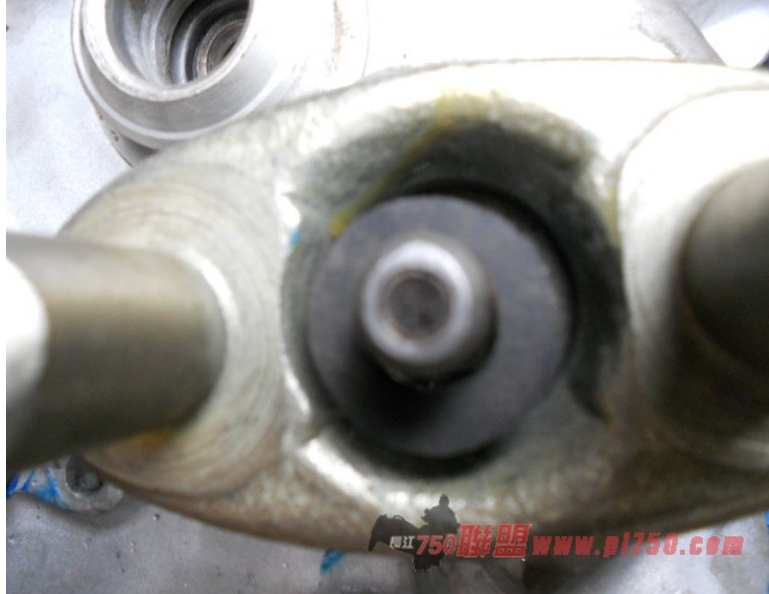
This shows an added seal improvised from a piece cut from an old inner tube.

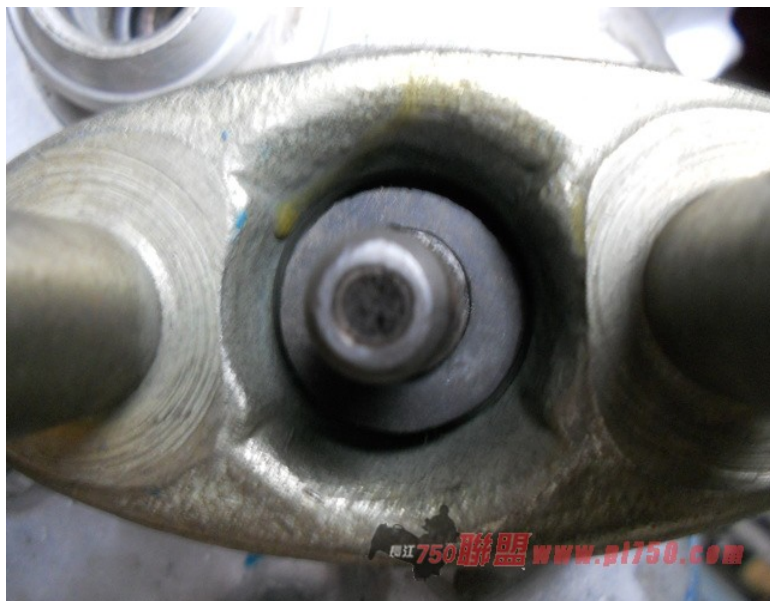
In addition, silicon sealant is applied under the retaining nut. Tighten well and install the cotter pin. This will stop any oil leaks via the splined shaft.
